Description: This unit changes the faired setting of the ailerons in flight to a setting below and above the neutral setting (0°) of the ailerons. It does so by changing the length of the stroke of the vertical push-pull aileron tubes located on the FS 94 bulkhead. The basic aileron torque tube bearings are removed and replaced by a cam. As the cam is rotated vertically by a cam. As the cam is rotated the aileron torque tube and vertical push-pull tubes are moved up and down. This will cause deflection of the aileron torque tube over its entire length, eliminating fatigue of the tube, and the use of universal joints.

The net effect of being able to change aileron settings in flight enables the pilot to fine tune the aircraft's flight and landing attitude for various weight and cg conditions. Also, in heavy rain, it's adjustment will help unload the canard and reduce trim changes due to rain effect.

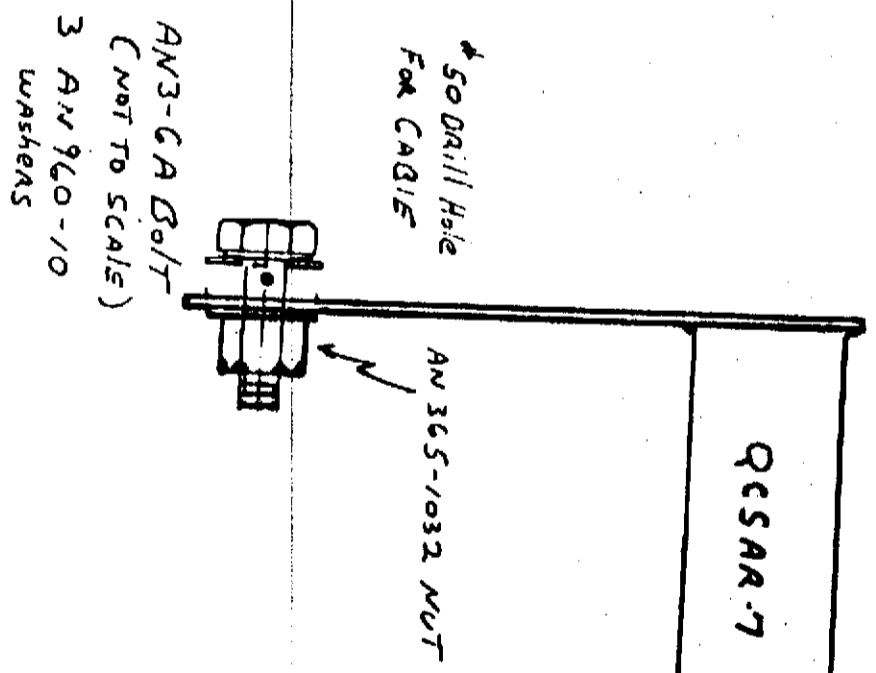
Make a cable mount block out of the piece of 1.5x1.5x.5 phenolic block supplied. Drill the 3/16 hole at the angle shown and drill the two 3/16 bolt holes next. Using a fine hacksaw, cut the block at the angle shown. A small rat tail file can be used to adjust the cable hole size. Flox the bottom in place and flox around the nuts on the bottom, they will act as nutplates when the flox is cured. Wipe a little grease on the bolt threads before installation so they will release from the threads after flox has cured.

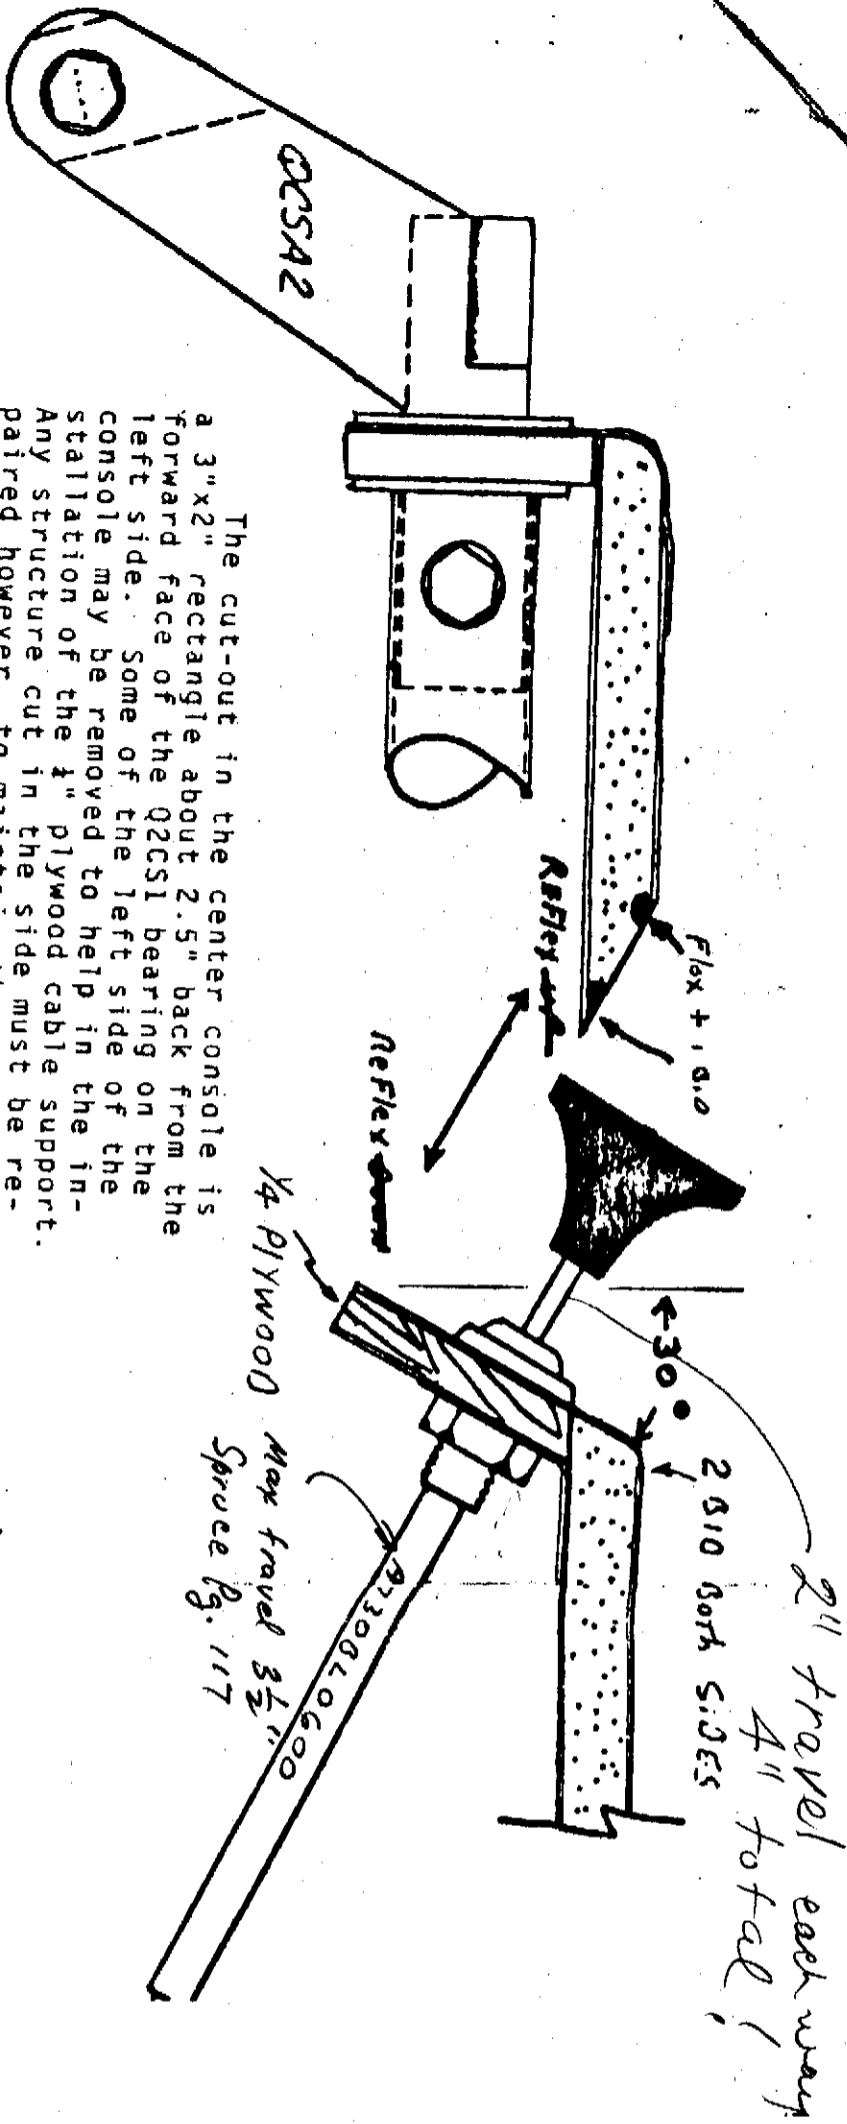
The cut-out in the center console is a 3"x2" rectangle about 2.5" back from the forward face of the Q2CS1 bearing on the left side. Some of the left side of the console may be removed to help in the installation of the 1" plywood cable support. Any structure cut in the side must be repaired however, to maintain the strength of the console. You will notice the flex cut-out area.

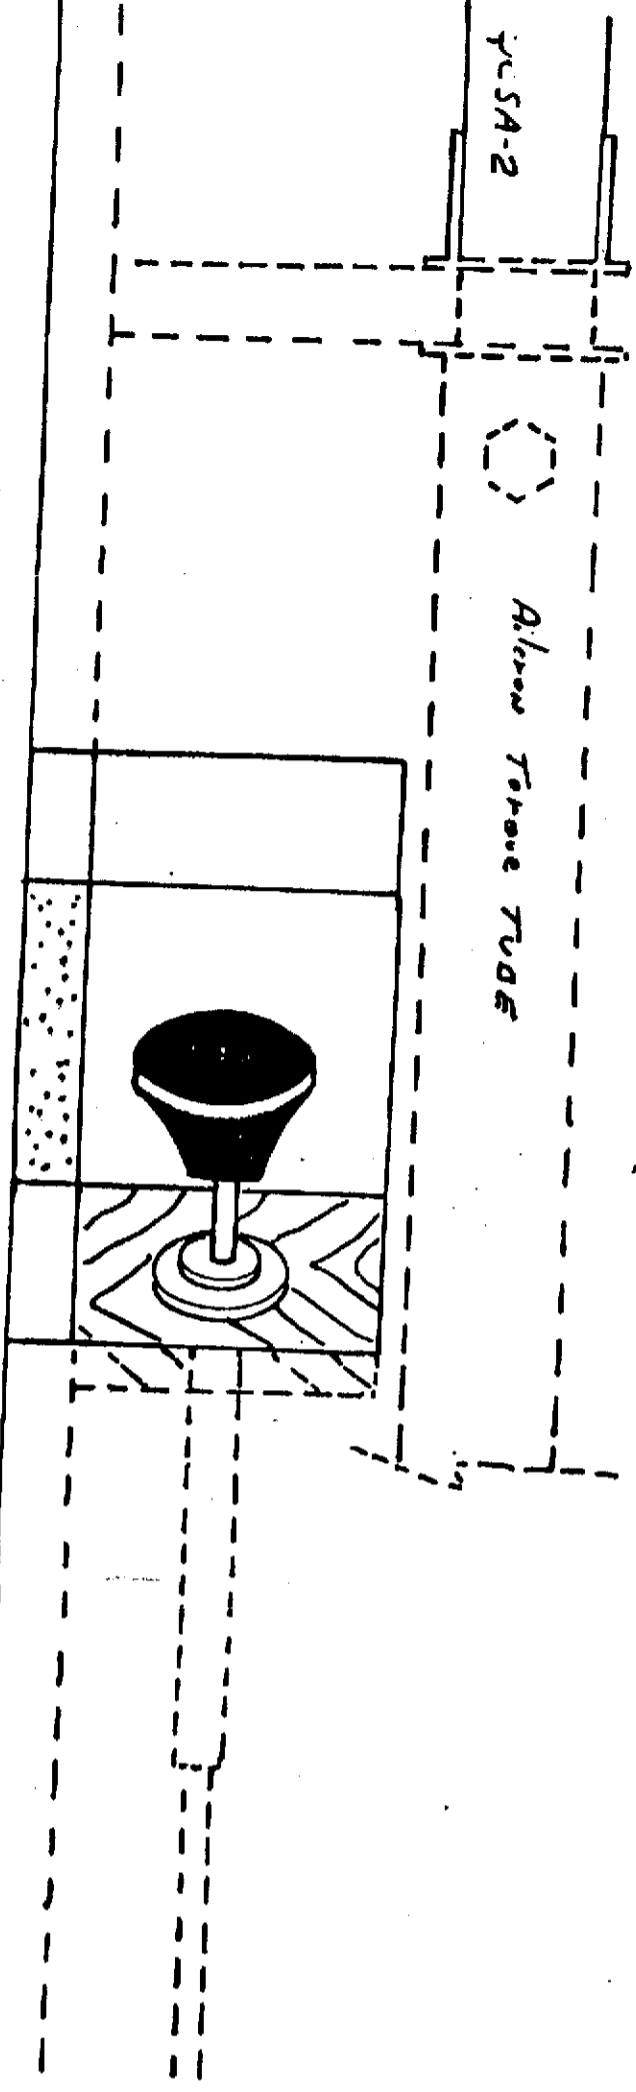
TOP of CENTER CONSOLE
(Looking down)

2" travel each way
4" total

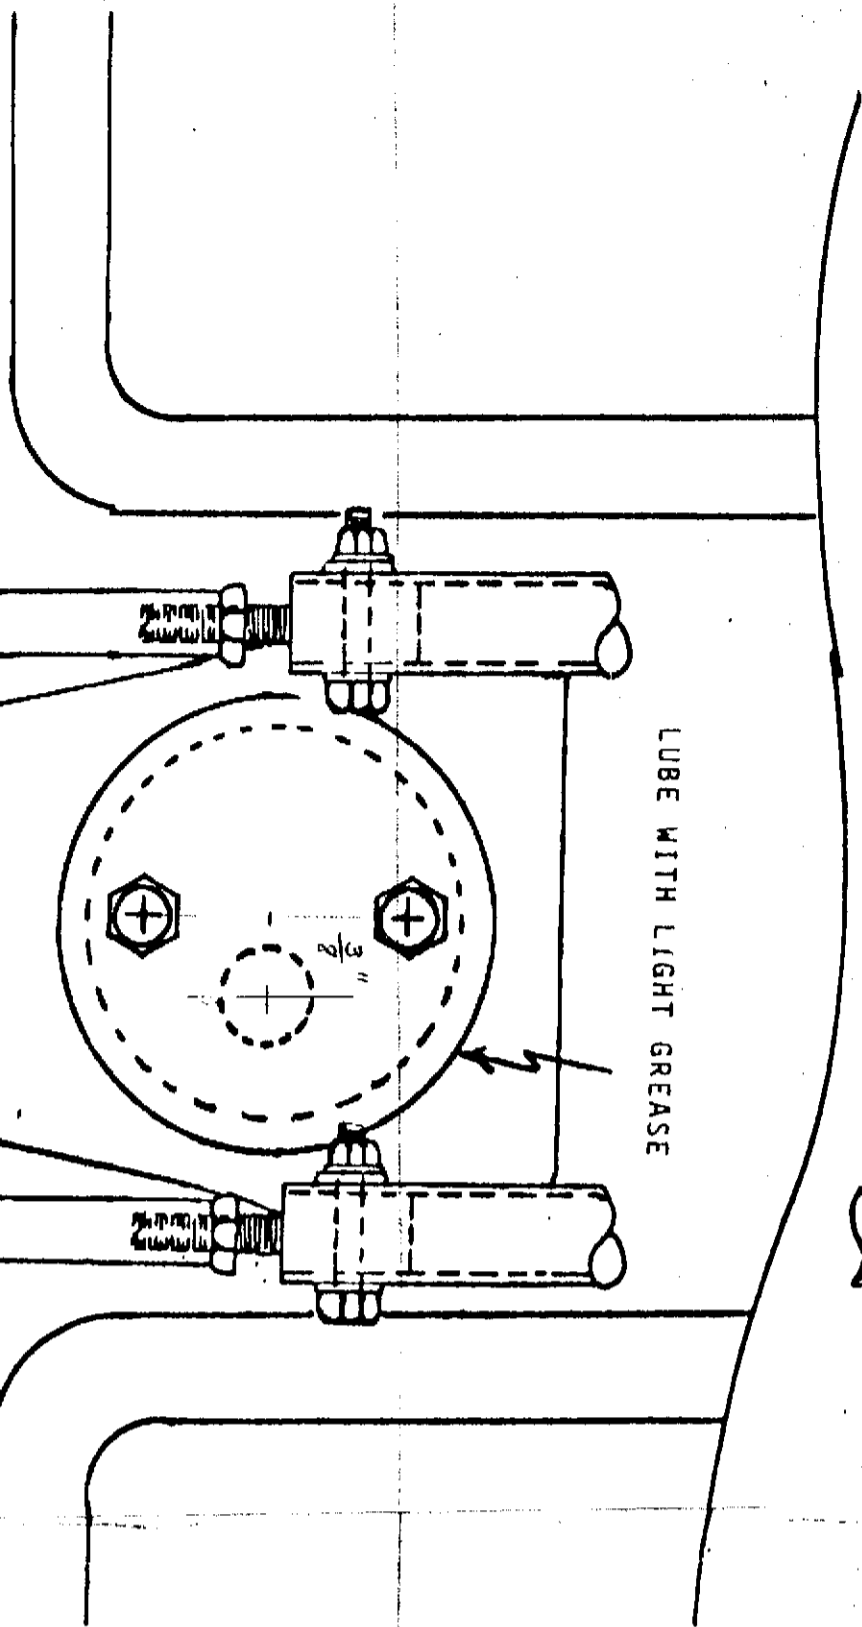
LOOKING APT SHOWING
PUSH-PULL CABLE

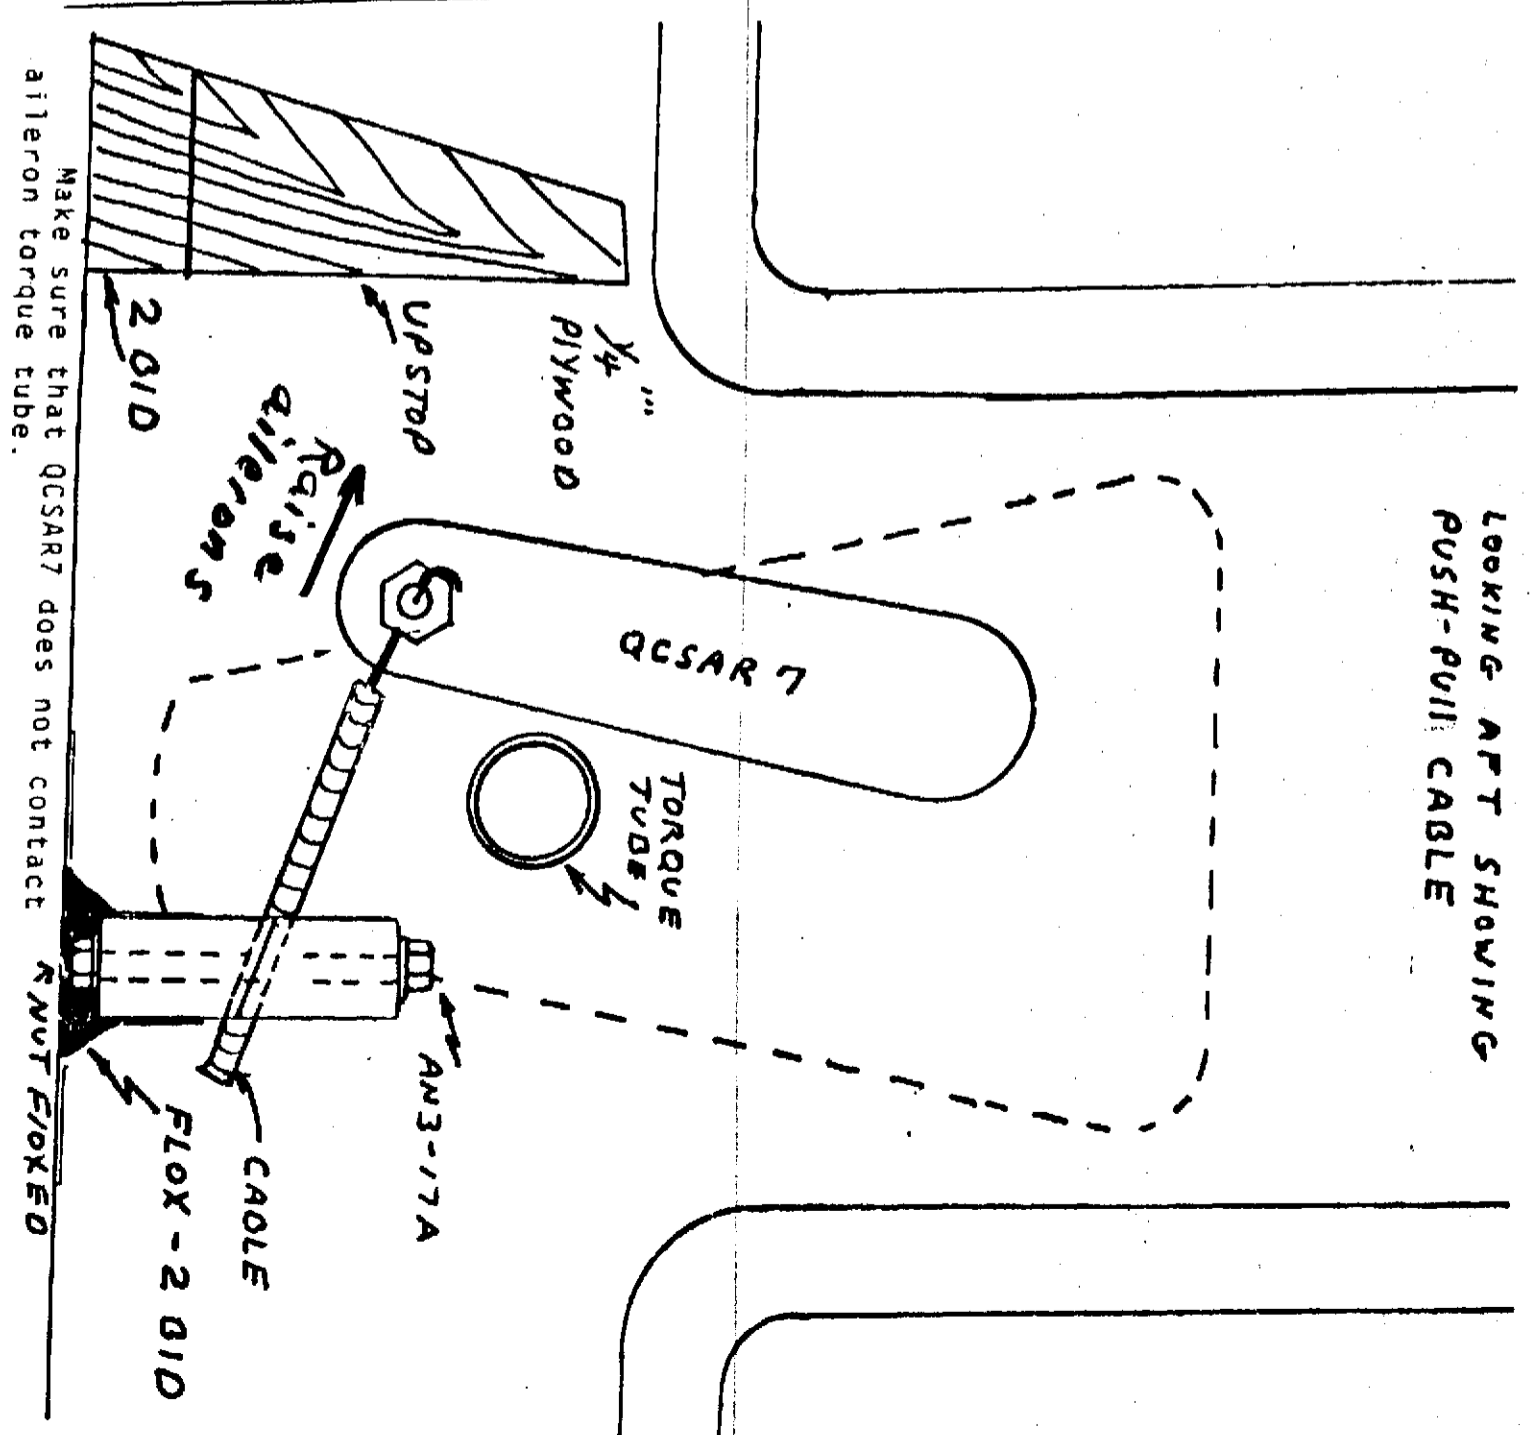
FS 94
BULKHEAD

Tighten castle nut to remove any
slap but not tight enough to bind. Keep
lubricated and inspect every 50 hours.
Make a note in your service guide.

LUBE WITH LIGHT GREASE

.24"
2.4" ±
(variable)

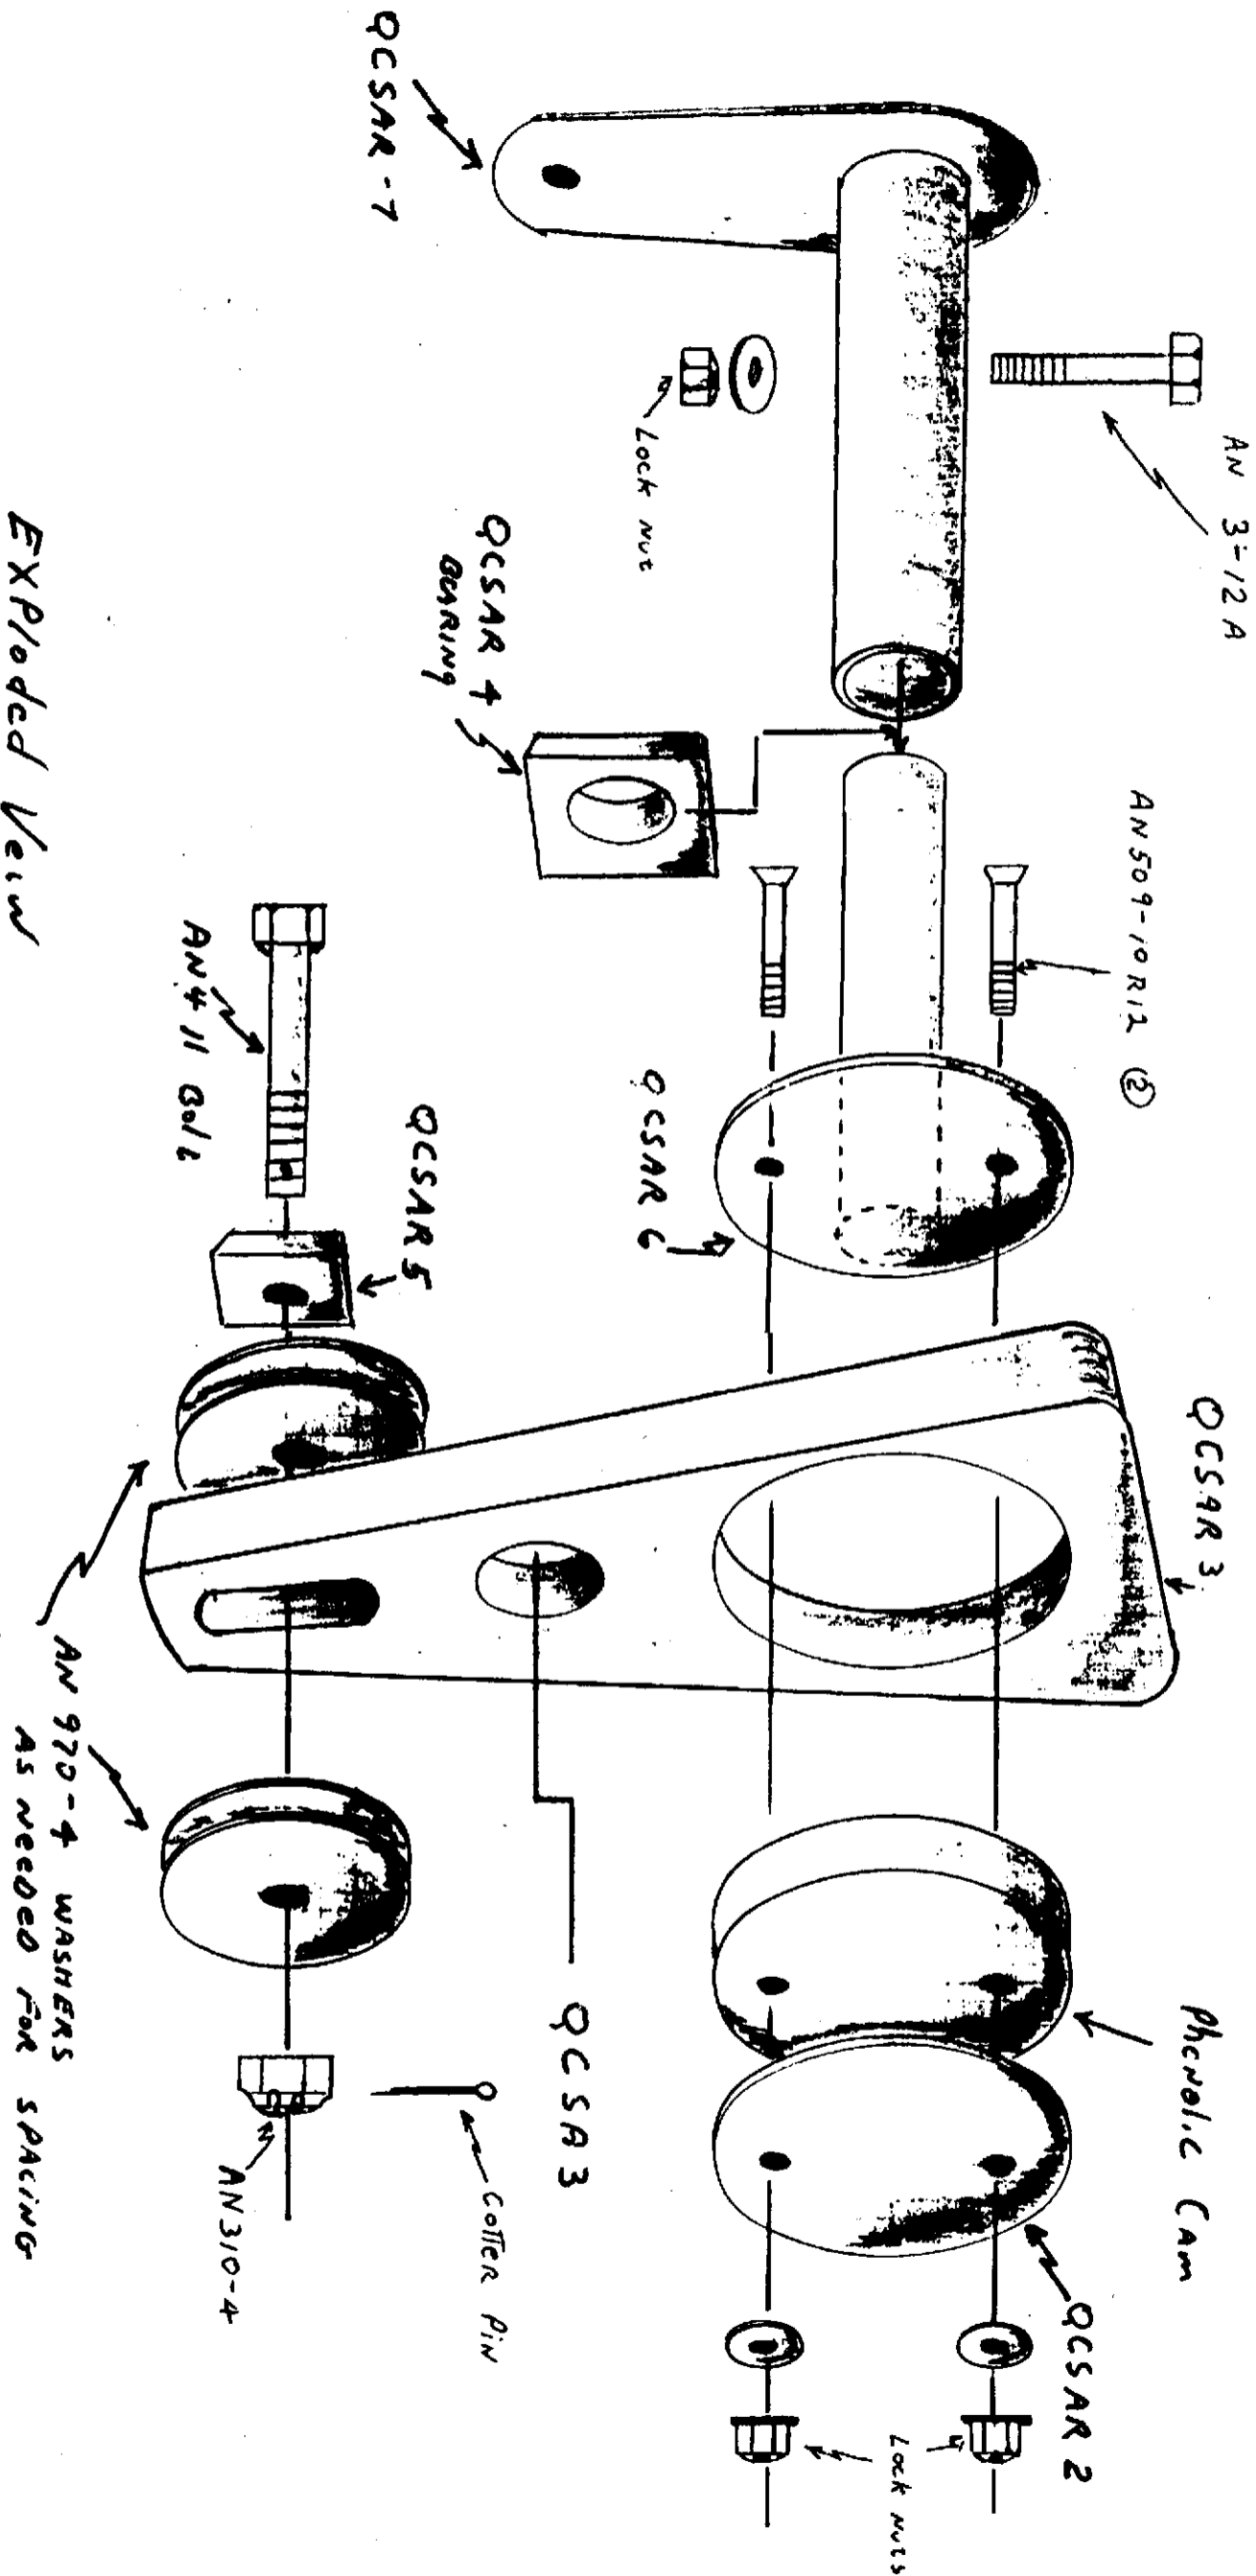
Exploded View

Looking aft

Inside fuselage
