DRAGONFLY BUILDERS AND FLYERS NEWSLETTER

VOLUME 78

JULY - AUGUST 1998

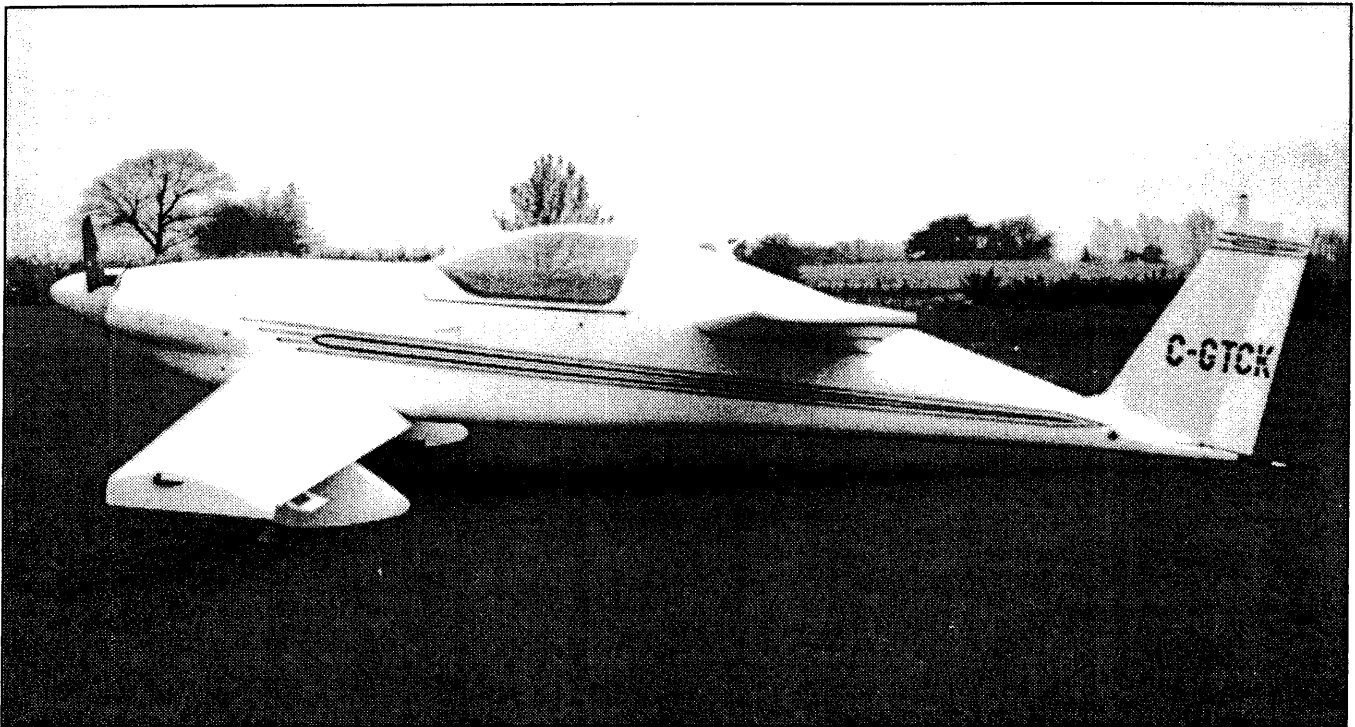
John Kunz's Beautiful Mark II Dragonfly

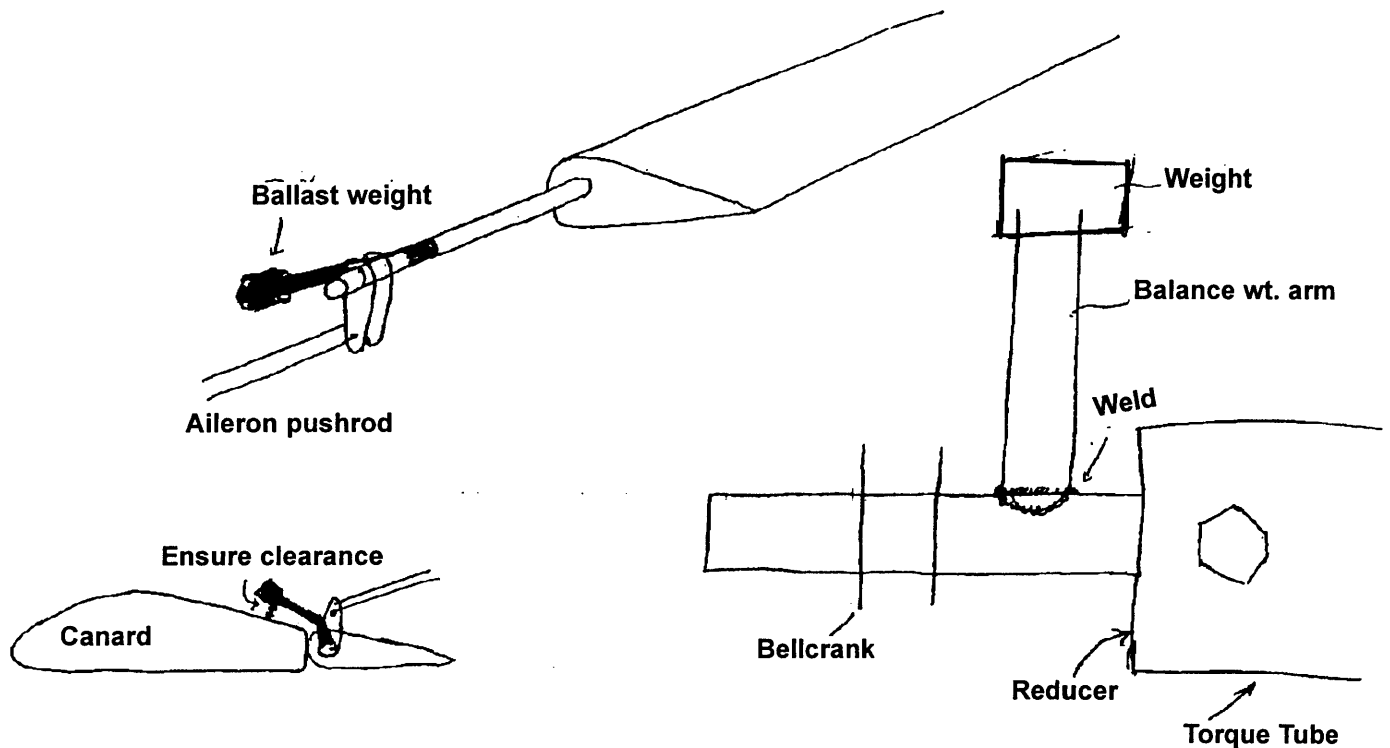
Below are drawing that Ted Givins has sent in on the subject. And the drawing where sent in by Tom Moore the editor of the Q-Talk (Quickie guy's) newsletter. Tom took these from an actual set of Q-2 plans. The drawings are not meant to be the absolute way to do this on your particular project, but are meant just to be "Food for thought"! Regards, Spud Spornitz

#2 An alternative method would to attach weights to the control arm and have them more in and out of the lower wing/canard surface.

Hollow out enough to allow for control deflection - be careful to only remove enough material to allow control deflection. I

Over the last twelve months one of the most mentioned topics was, "How do you mass balance?" This is all brought on by the larger and more powerful engines that are being installed. Bare in mind a couple of things. The never exceed speed of the Dragonfly is 180 MPH. Rex Taylor said that Bob Walters did do a full flight test program to that speed. Mass balancing will help, but is not a replacement for a sloppy control system.

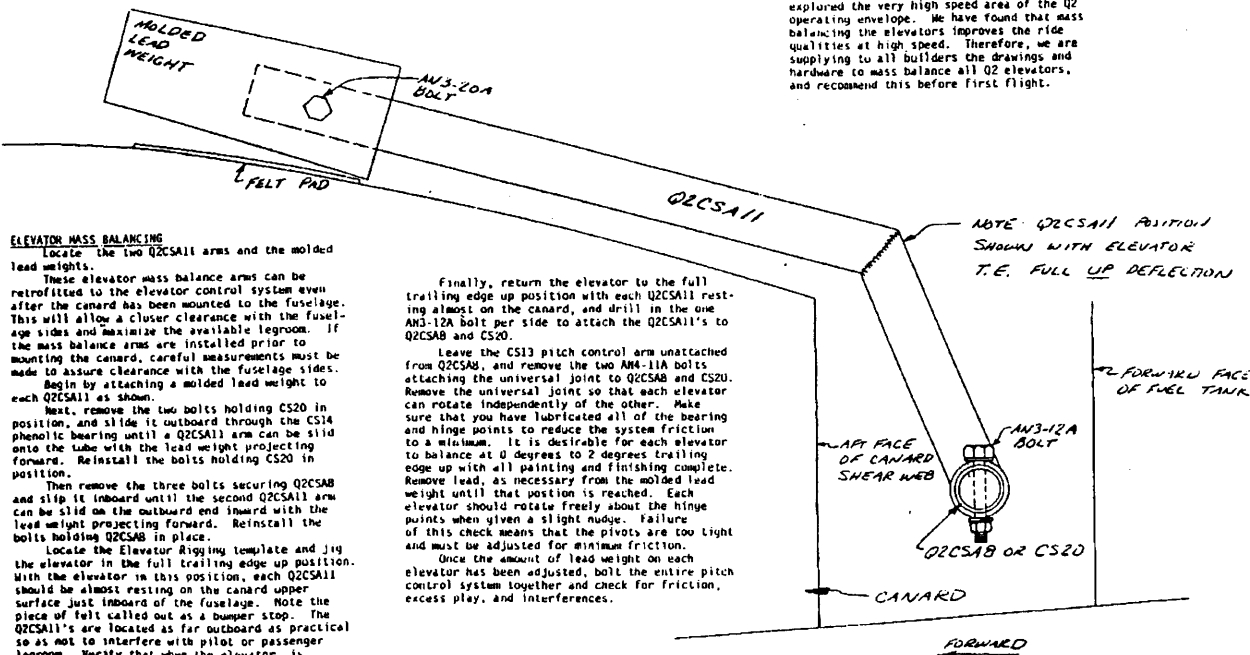
ELEVATOR MASS BALANCING

MASS BALANCING ELEVATORS. In preparation for testing on turbocharged Revmasters and possible A-65 thru C-85 installations, we have further explored the very high speed area of the Q2 operating envelope. We have found that mass balancing the elevators improves the ride qualities at high speed. Therefore, we are supplying to all builders the drawings and hardware to mass balance all Q2 elevators, and recommend this before first flight.

Locate the two Q2CSA11 arms and the molded lead weights.

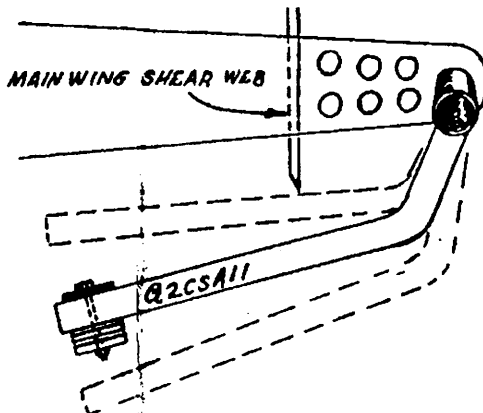
AILERON MASS BALANCING

The ailerons are balanced for obvious reasons of higher speed, and can be accomplished fairly fast. Assuming, of course, your aircraft can be disassembled behind the rear wing. As with the elevators, the ailerons should be as friction free as possible. The ailerons are bolted on the end of the internal balance arm to bring each aileron to full or slightly leading edge heavy balance. Make sure there is no interference with the arm for full aileron travel. Remember to disconnect ailerons from each other when balancing.
